The compact versions of the MCS/MCE family have a smaller space between the inner wall of the cylinder and the outside of the piston rod than the 9130 family:

Therefore, in the versions with joints, the correct plumbing of the piston with respect to the guides throughout its travel is of vital importance. A defect in plumbing will cause the bottom of the piston rod to hit when passing through the sleeve joint if the sleeve is not vertical to the piston rod.

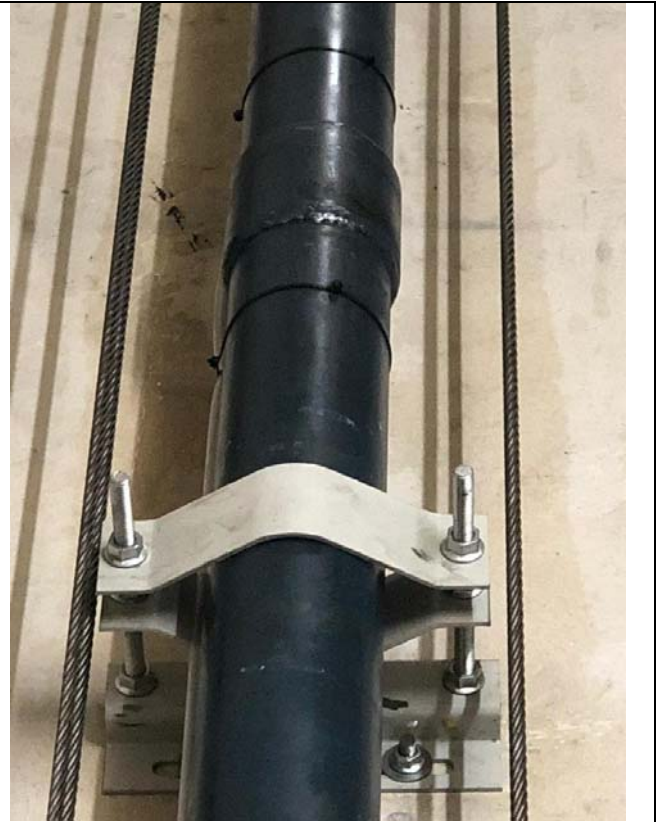
1° It is very important that there is a fixation of the shirt near the union to guarantee the plumbing. Otherwise it is very difficult to successfully plumb the piston.

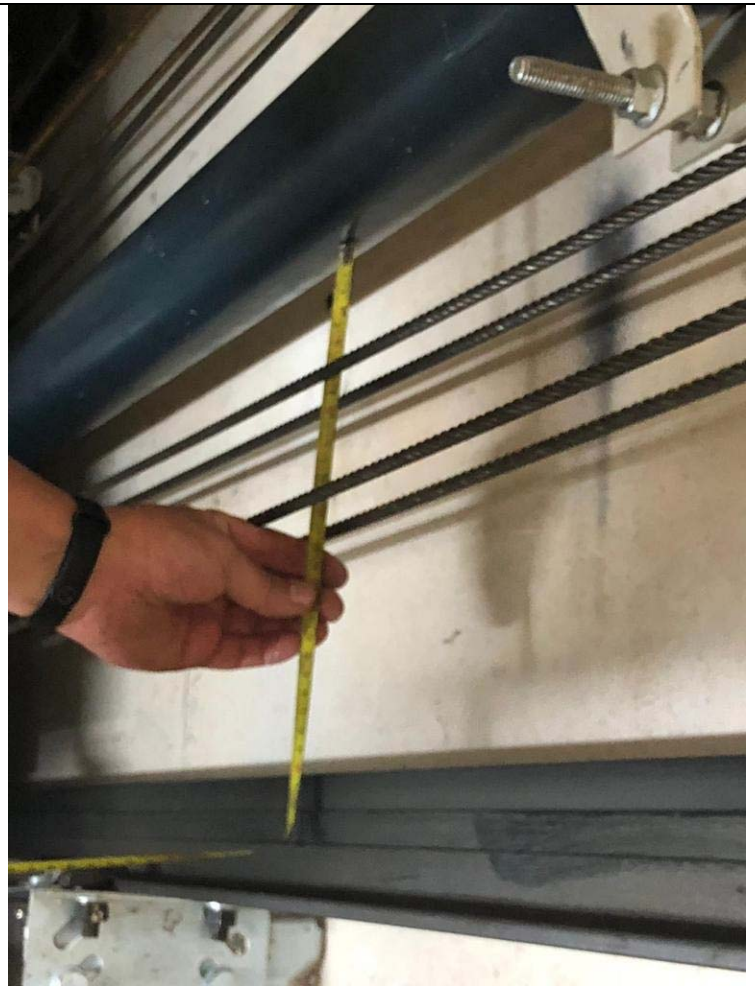
If this is not corrected, take measurements between the outside of the piston rod and the guide in the last sections, as the piston head may be binding to the piston in the last section.

3° Check that the liner is in the same position with respect to the guides, in case of having different measures correct in this axis by loosening the piston fixation and correct its position.
