The compact versions of the MCS/MCE family have a smaller space between the inner wall of the cylinder and the outside of the piston rod than the 9130 family:

Therefore, in the versions with joints, the correct plumbing of the piston with respect to the guides throughout its travel is of vital importance. A defect in plumbing will cause the bottom of the piston rod to hit when passing through the sleeve joint if the sleeve is not vertical to the piston rod.

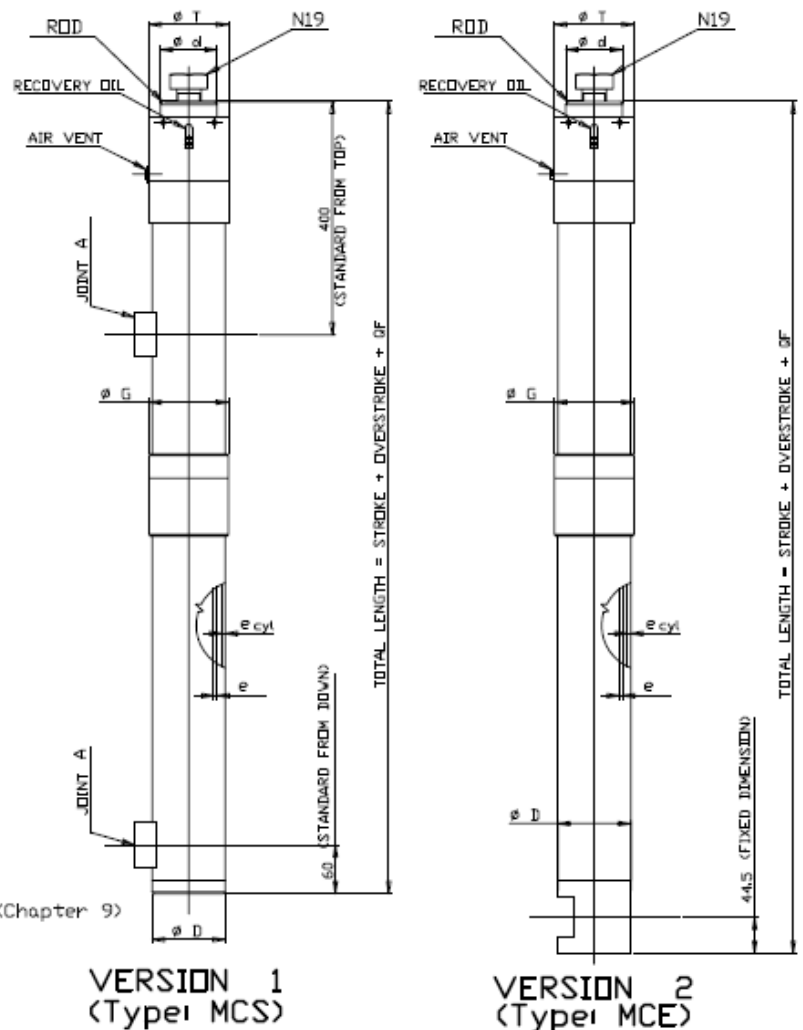
Shaft diameter (mm)	Space between the inside of the liner and the bottom of the piston rod (mm)
80	3,2
70	3,8

In case the bottom of the piston rod hits the sleeve joint, follow the recommendations below to correct the installation problem:

1° It is very important that there is a fixation of the shirt near the union to guarantee the plumbing. Otherwise it is very difficult to successfully plumb the piston.

2° Check along the whole stroke that the piston liner is plumb with respect to the cabin. In case of having different measures, correct in this axis the position of the piston with the booth by playing with the piston fixings to the wall.

3° Check that the liner is in the same position with respect to the guides, in case of having different measures correct in this axis by loosening the piston fixation and correct its position.

In 98% of the cases a correct positioning of the shirt corrects the problem.

4° If you continue with the blow, proceed to introduce a ladder in the pit to reach the union. From the ladder, proceed to fix the loose piston, to test up and down the cabin in the impact area and see which direction is correct to plumb the piston, with your hands on the sleeve joint you can see in which area of the sleeve is hitting the rod. With the help of a sergeant correct the position of the shirt in relation to the stem. Correct until the blow disappears.
